## **Smoke and Dye Testing Summary**

### **High Level Sewershed**

Run Summa	ry ——						
Test ID	Test Type	Date Inspected	Company / Super.	Blower MH	Ground Condition	Notification Made?	Total Length
S1028-029	Smoke	8/18/2008	ADS/TM	S11YY_008MH	Dry	Yes	1,307.15

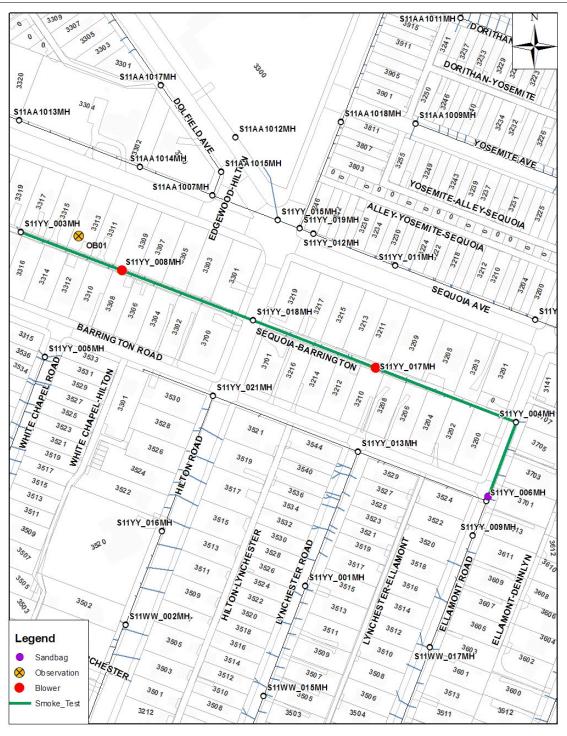
**Picture** \S1028-029-OB01-P01.jpg

**Obs\_ID** \$1028-029-OB01 **Address** 3313 Sequoia Ave

**Location** Yard - back **Nearest MH** S11YY\_008MH

Comments Smoke from cleanout in back yard access

through alley way. 3313 Sequoia Ave.

**Comments** Back of house, 3313 Sequoia Ave.
